Spotlight on Damp & Mould

Mid Devon Housing's Damp, Mould & Condensation Approach

Mid Devon
Housing

Presentation date:
23 April 2024

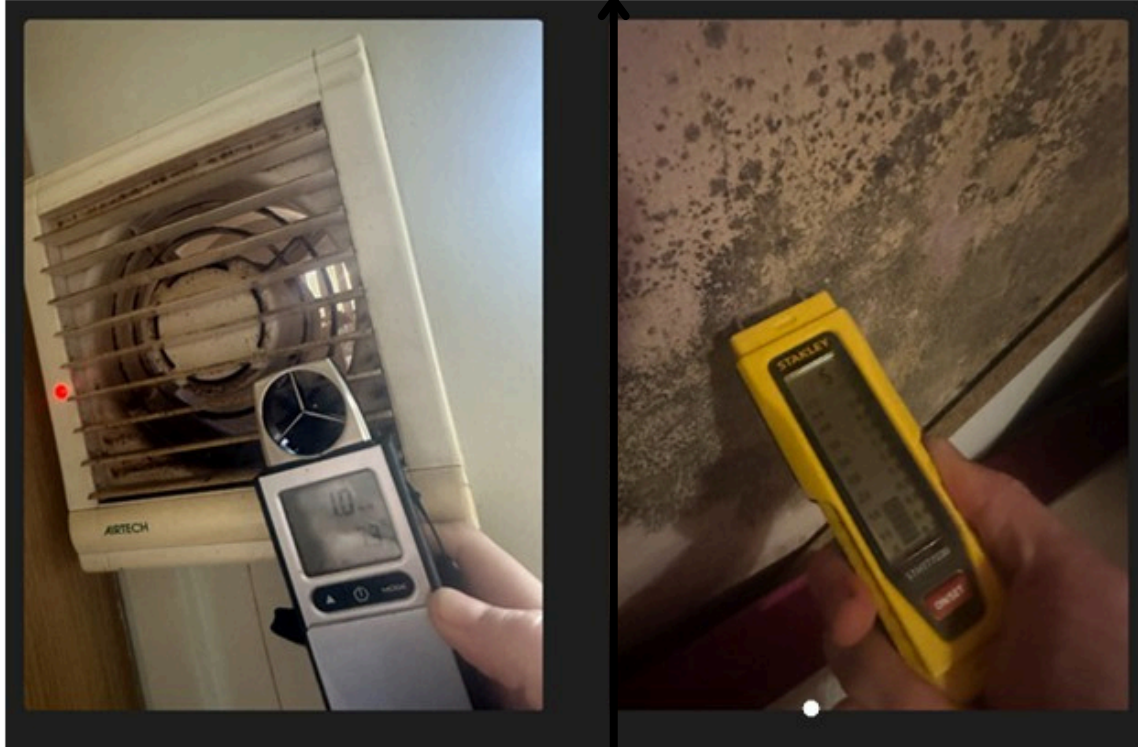
Attached are photos for [redacted]
Bedroom mould - the bed is pushed against the wall and there is no air flow in there. Curtains are pulled, door is kept shut and they are watching TV in there.

This simple bit of communication told us we didn't need to explore for leaks or mechanical ventilation issues, and would normally trigger some advice being provided. Vulnerability data highlighted a mental health need, which led to a physical visit. This then led to identification of hoarding, poor mental health, financial issues and safeguarding referral.

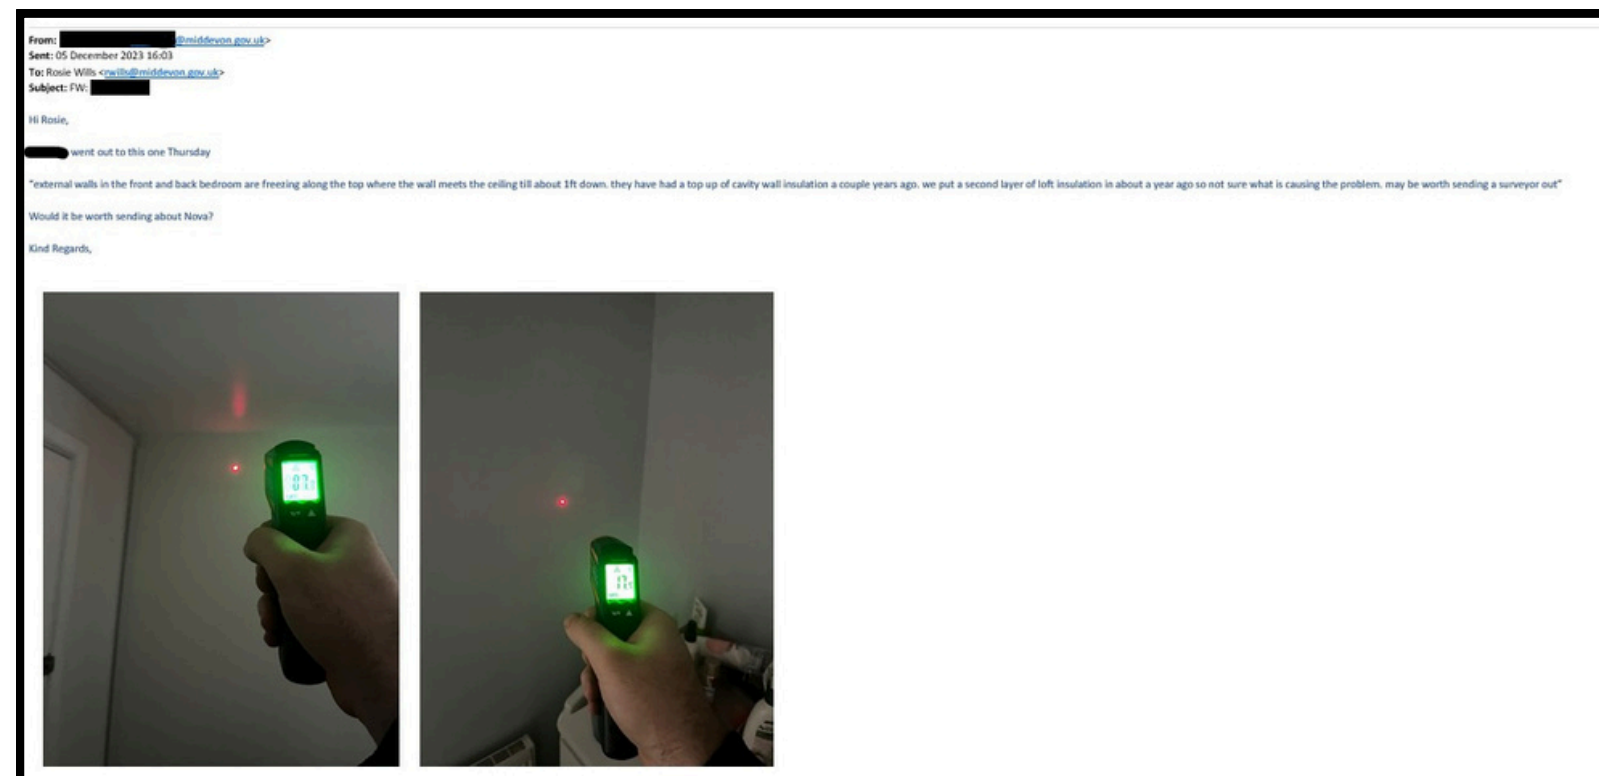
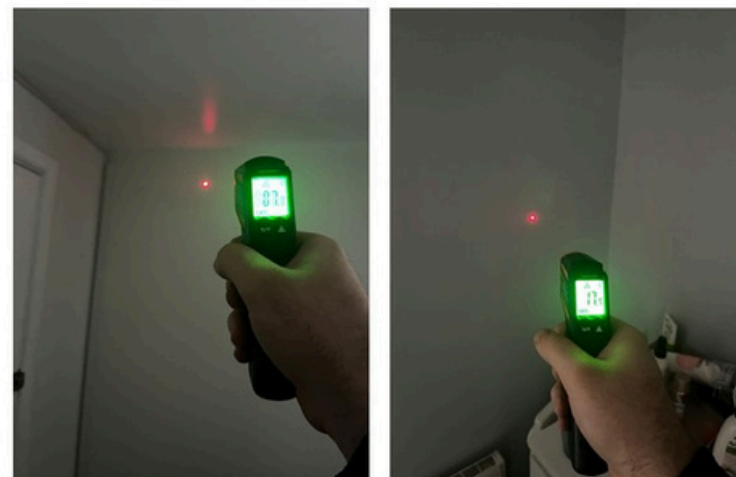
Both reports back from a mason just out of his apprenticeship, who was able to attend sooner than a technical inspector. Was able to check roofing, guttering, insulation etc and clearly advise what wasn't the issues, suggesting what is likely to be the issues. Trusting operatives with their judgement means we can fasttrack to contractor (in both cases suspected cavity fill issues)

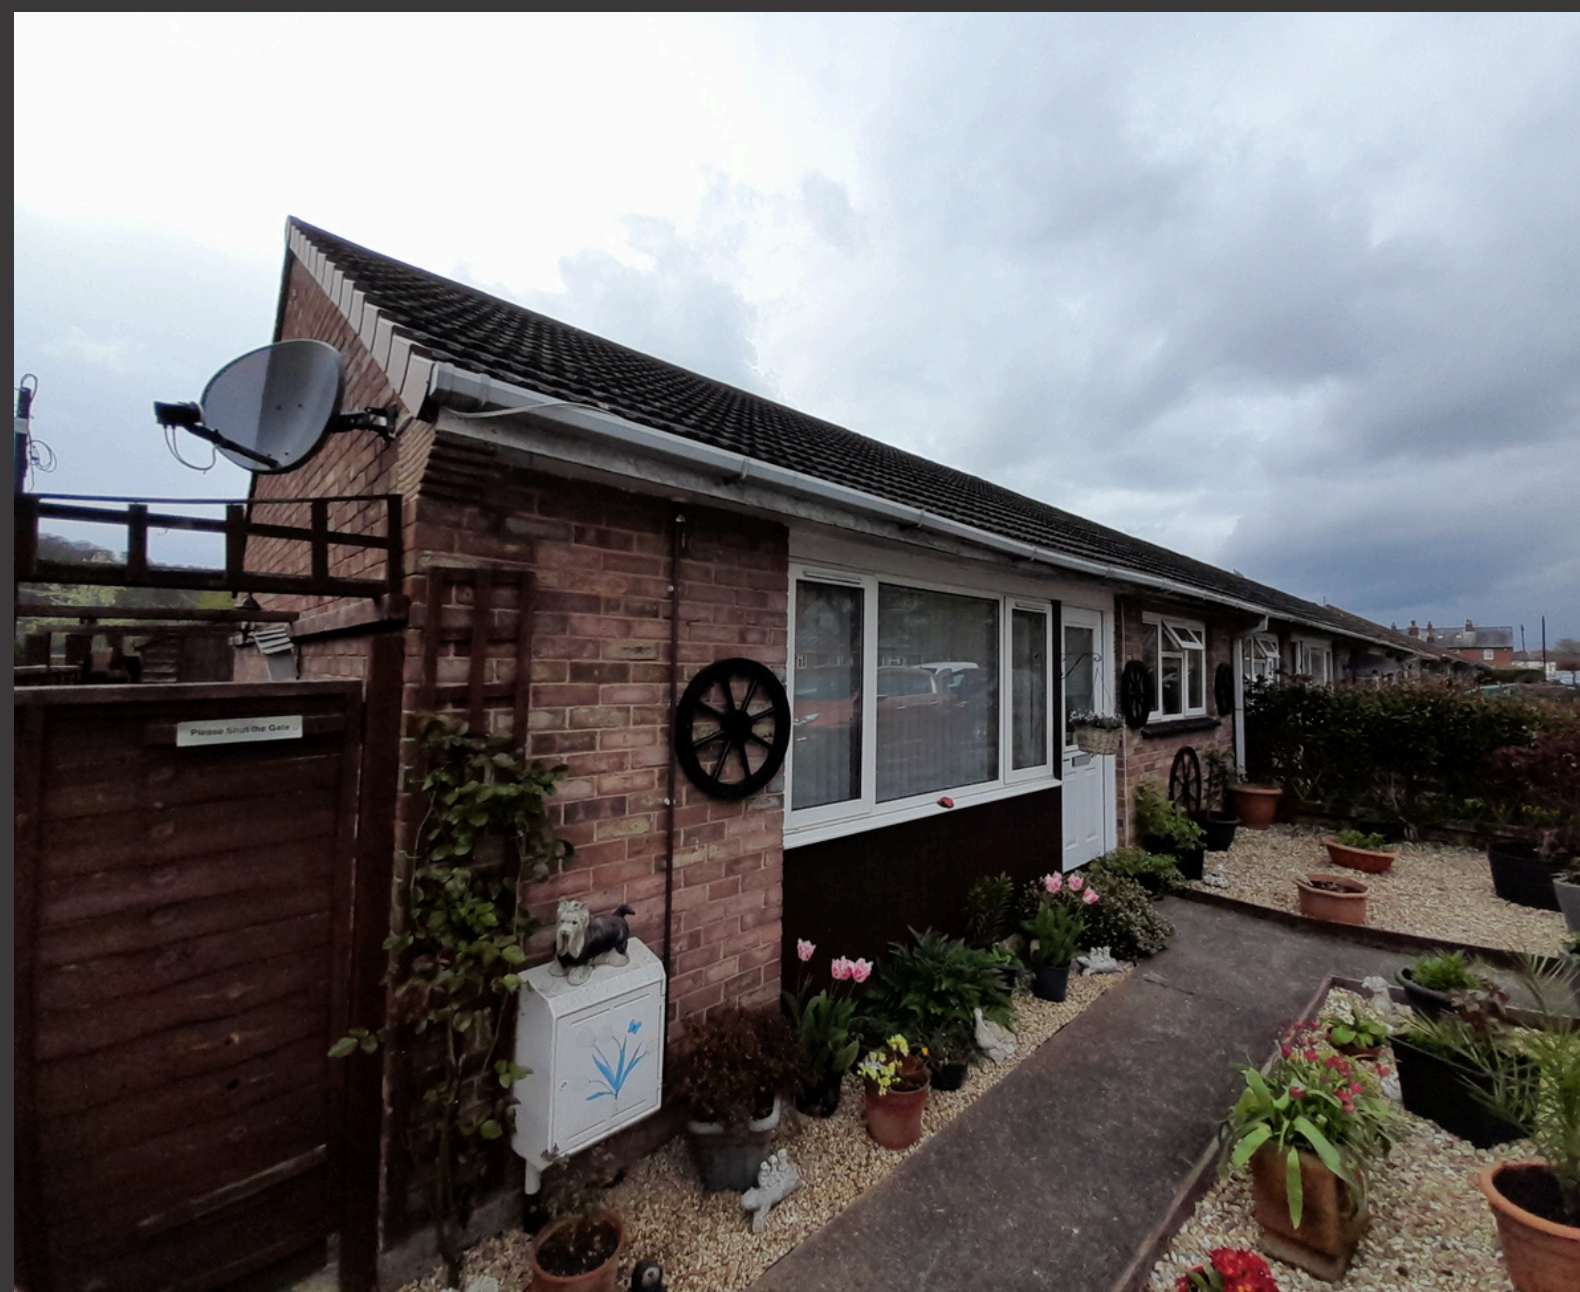
Case Study 1 – Mrs Smith

- 2 bedroom end terrace,
- No recorded history of damp or mould during 2 previous tenancies between 2008 and 2015.
- Mrs Smith moves in April 2015 after decant from very similar bungalow.
-
- No changes to heating, windows, ventilation or insulation during void period. No damp or mould present during void period
- First damp issues reported Feb 2015, then roughly every other winter (February generally after that, in different rooms.
- Works recommended 2023, second inspection and independent survey
- Tenant insight taken on face value in relation to temperature and humidity patterns.

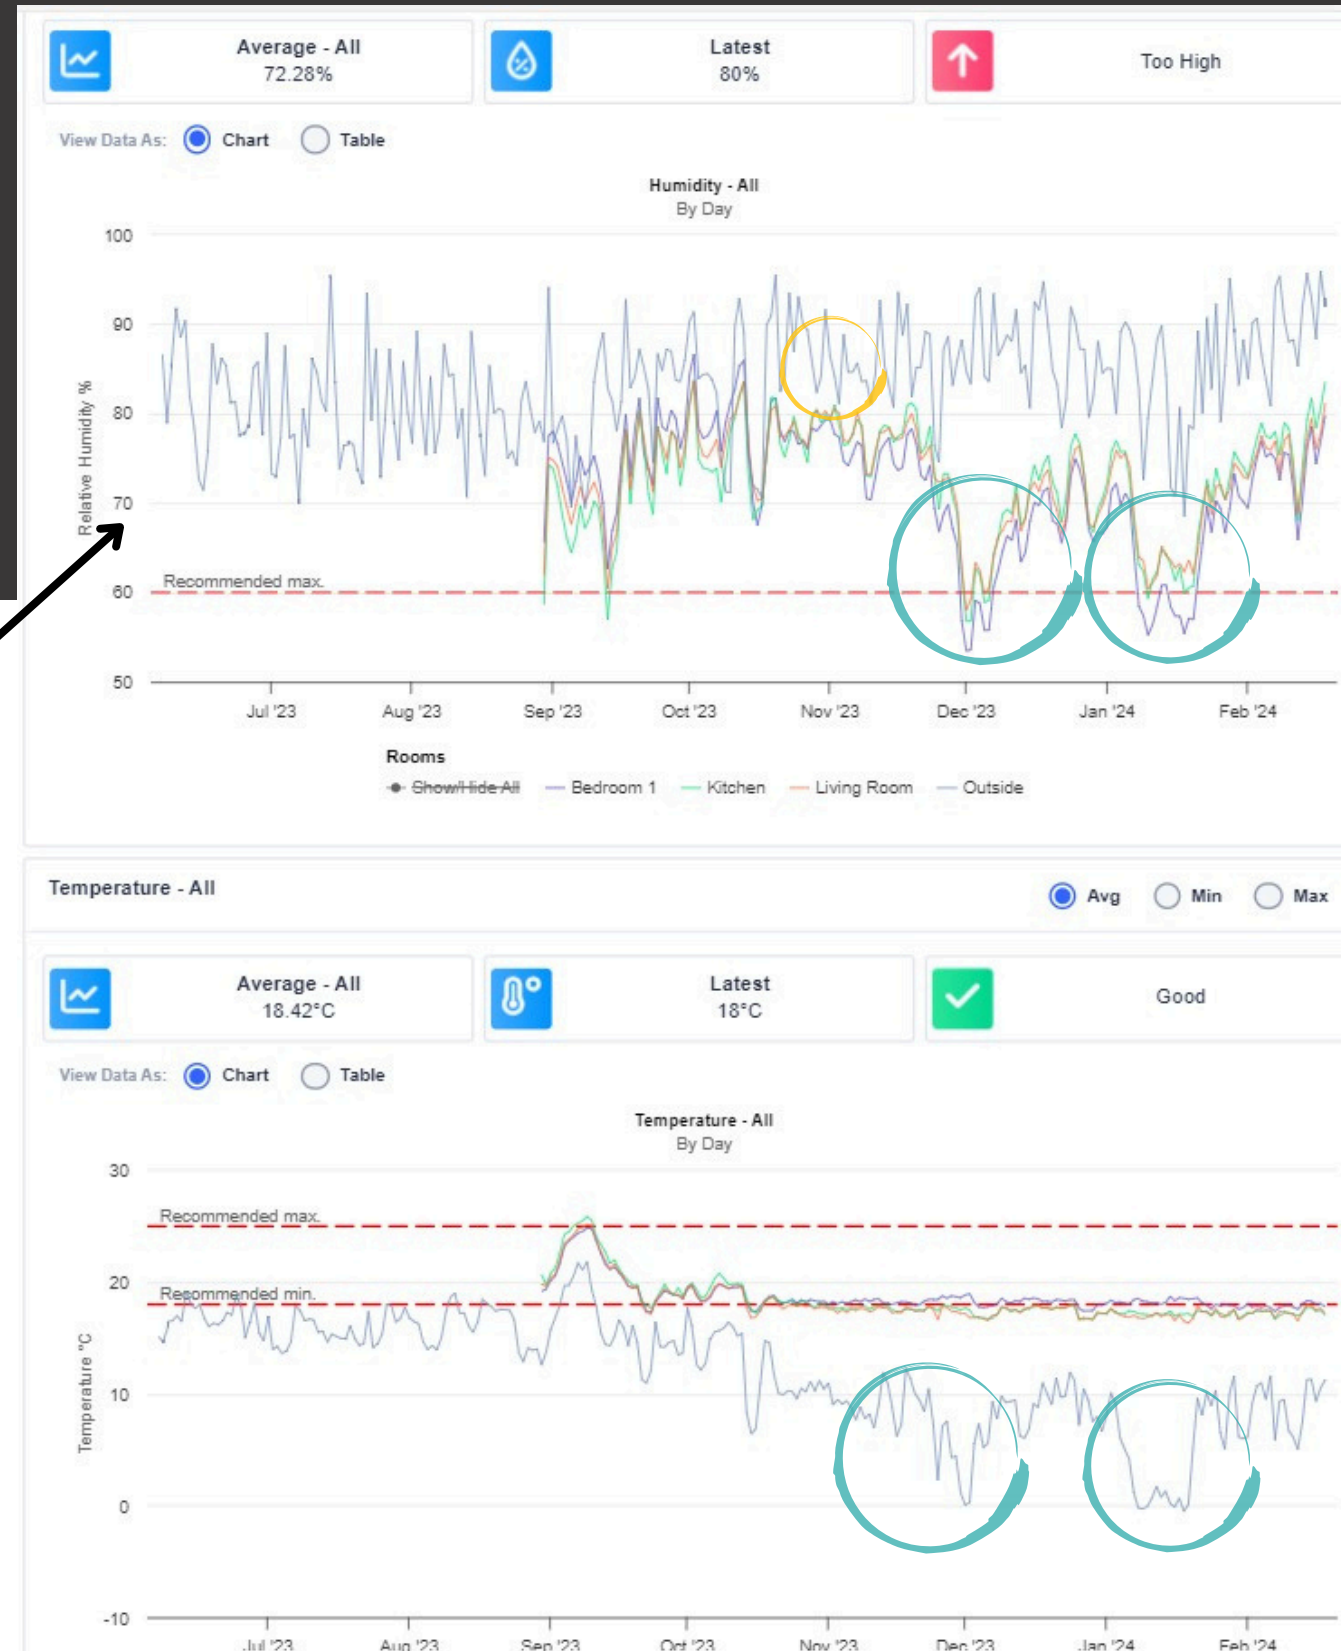
Main issue:

Low indoor
temperatures

Isolated drops in
humidity:
Consistent with
drops in outdoor
temperature close
to 0°C, which often
leads to drier indoor
relative humidity

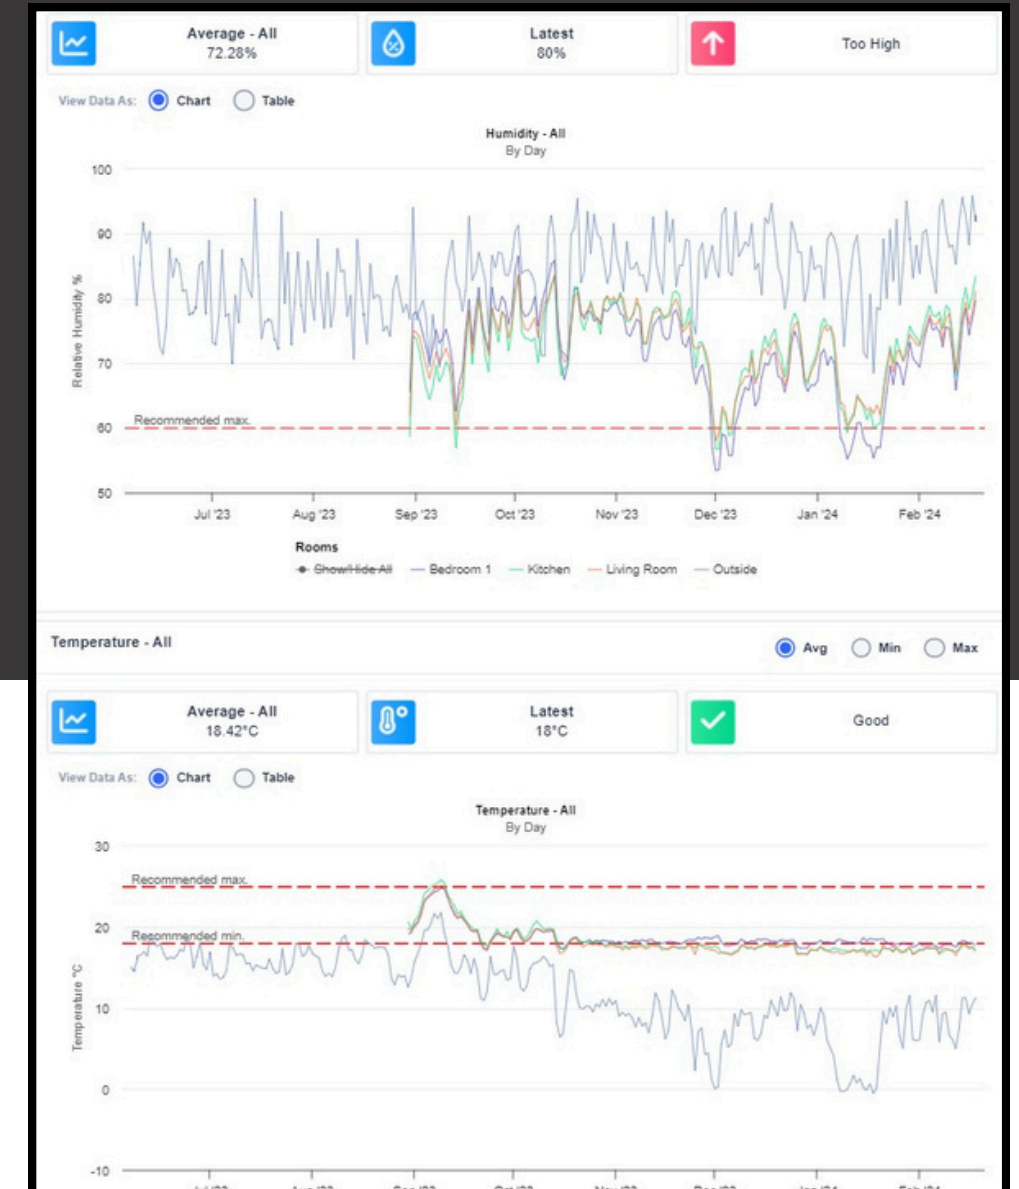
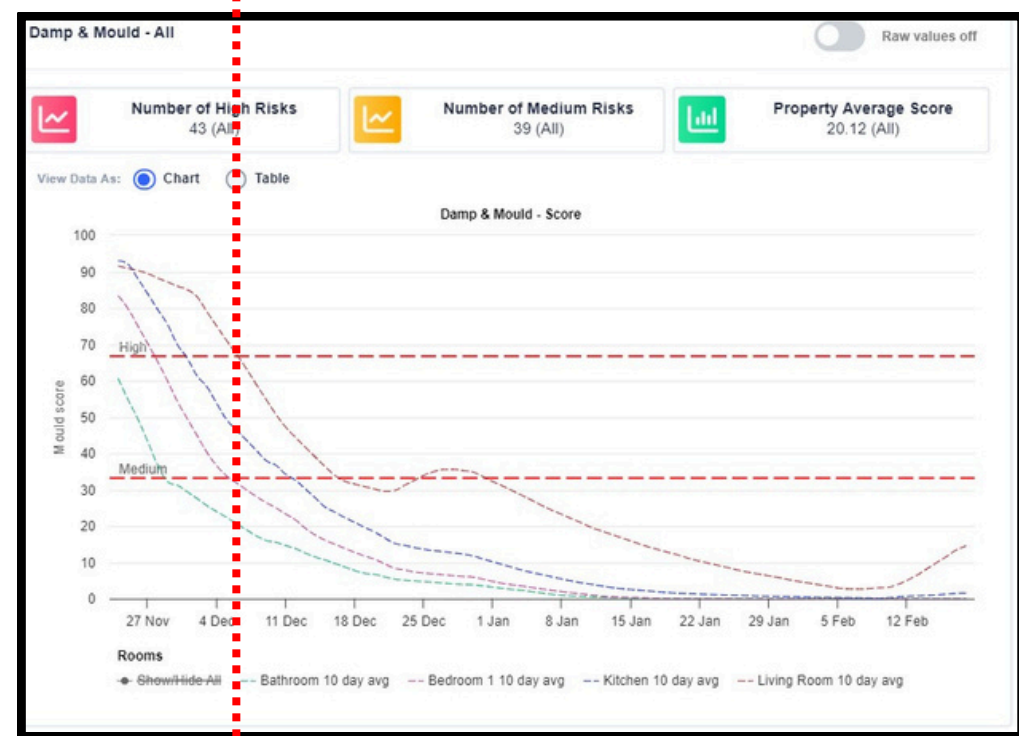
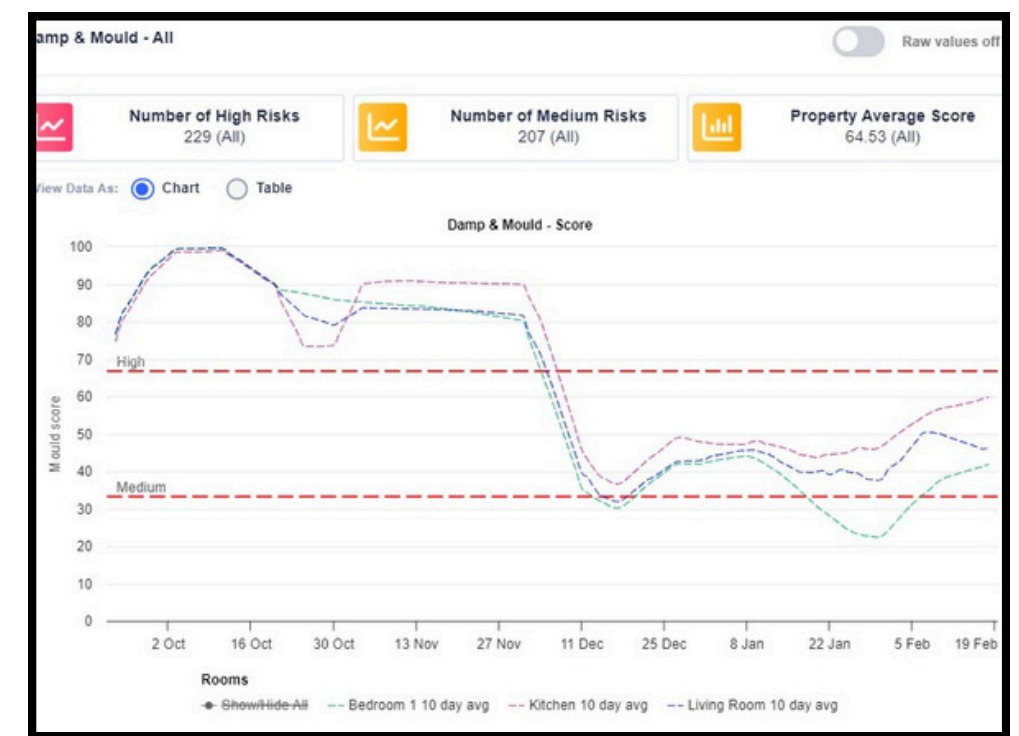
Mrs Smith's home

- Identical archetype and history
- Same street
- Same occupancy levels
- No visible dampness in control property, but 'damp' meter readings were identical - suggesting higher moisture content as standard.
- Occupancy didn't make any difference - humidity was high in control property during unheated void period
- The only difference between the two properties is the average temperature

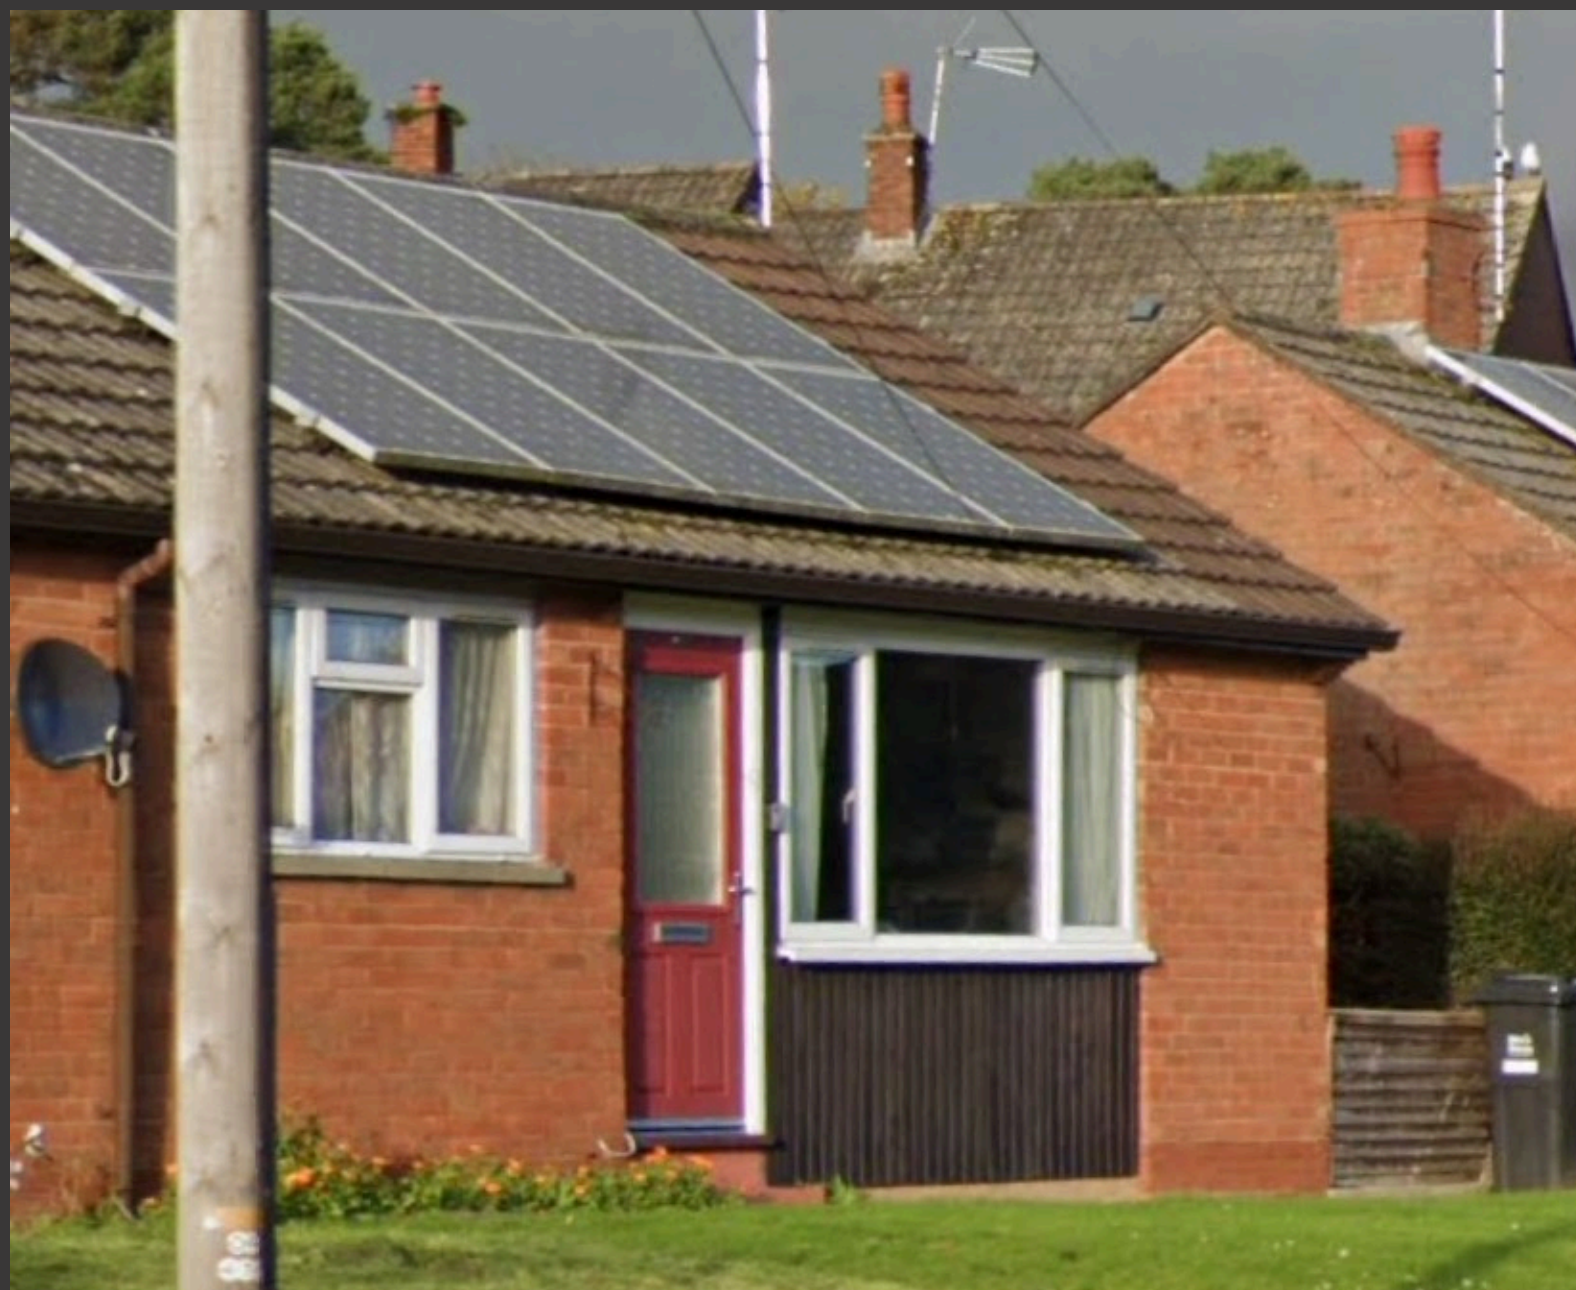
Case Study 2 - Mrs Lopez

- 1 bedroom end terrace bungalow
- No recorded history of damp or mould between 2008 and 2019. No changes to heating, windows, ventilation or insulation during void period. No damp or mould present during void period.
- Current occupant move in 2019
- Mould issues first reported towards end of first winter in property
- other history - disrepair claim. Claim primarily about a roof leak.

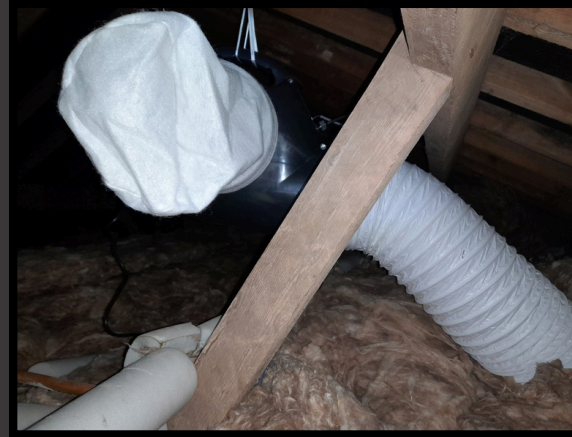
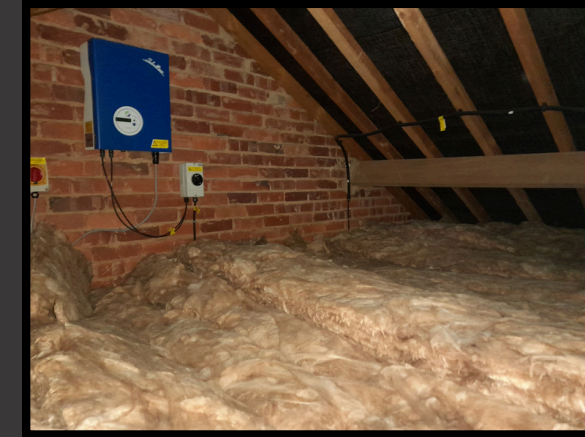
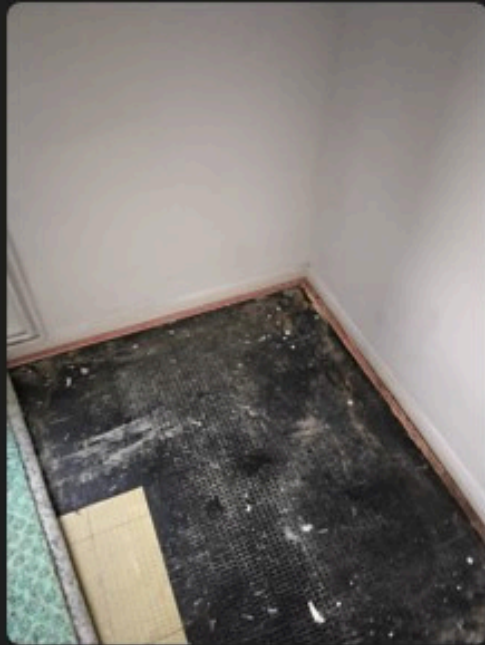
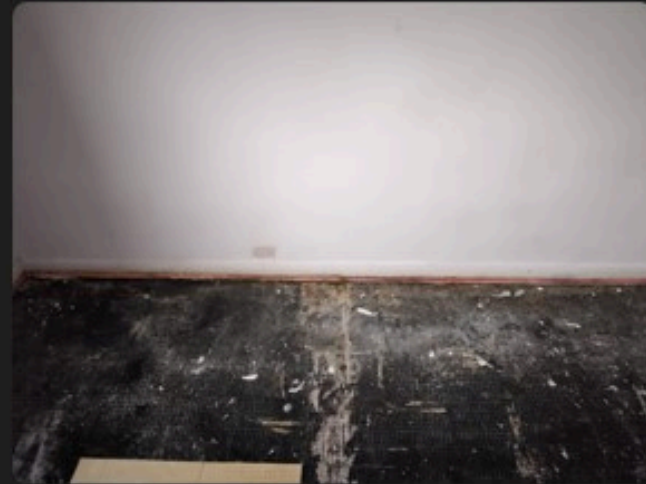
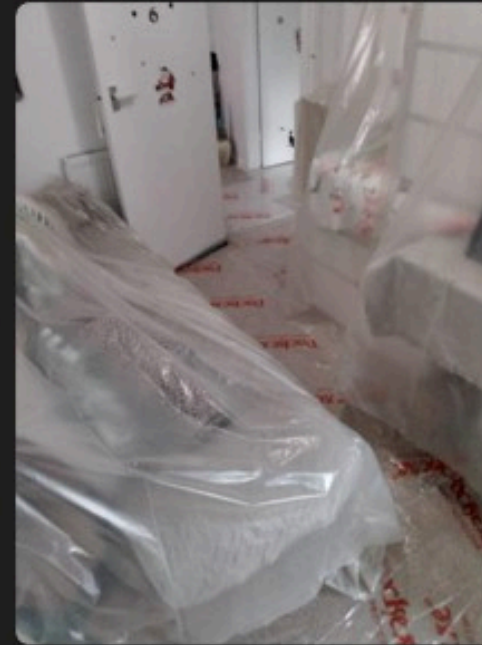
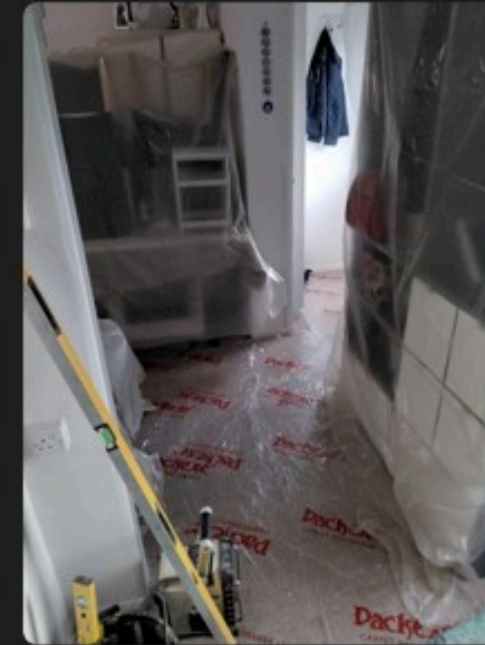
Case Study 2 Interventions

- Resin DPM installed to front bedroom and bathroom
- LAS install
- Renewal of possibly defective gulley to corner of front bedroom
- Kitchen fan installed, bathroom fan checked.
- Isolated repointing completed
- Concrete ramp bridging DPC redesigned

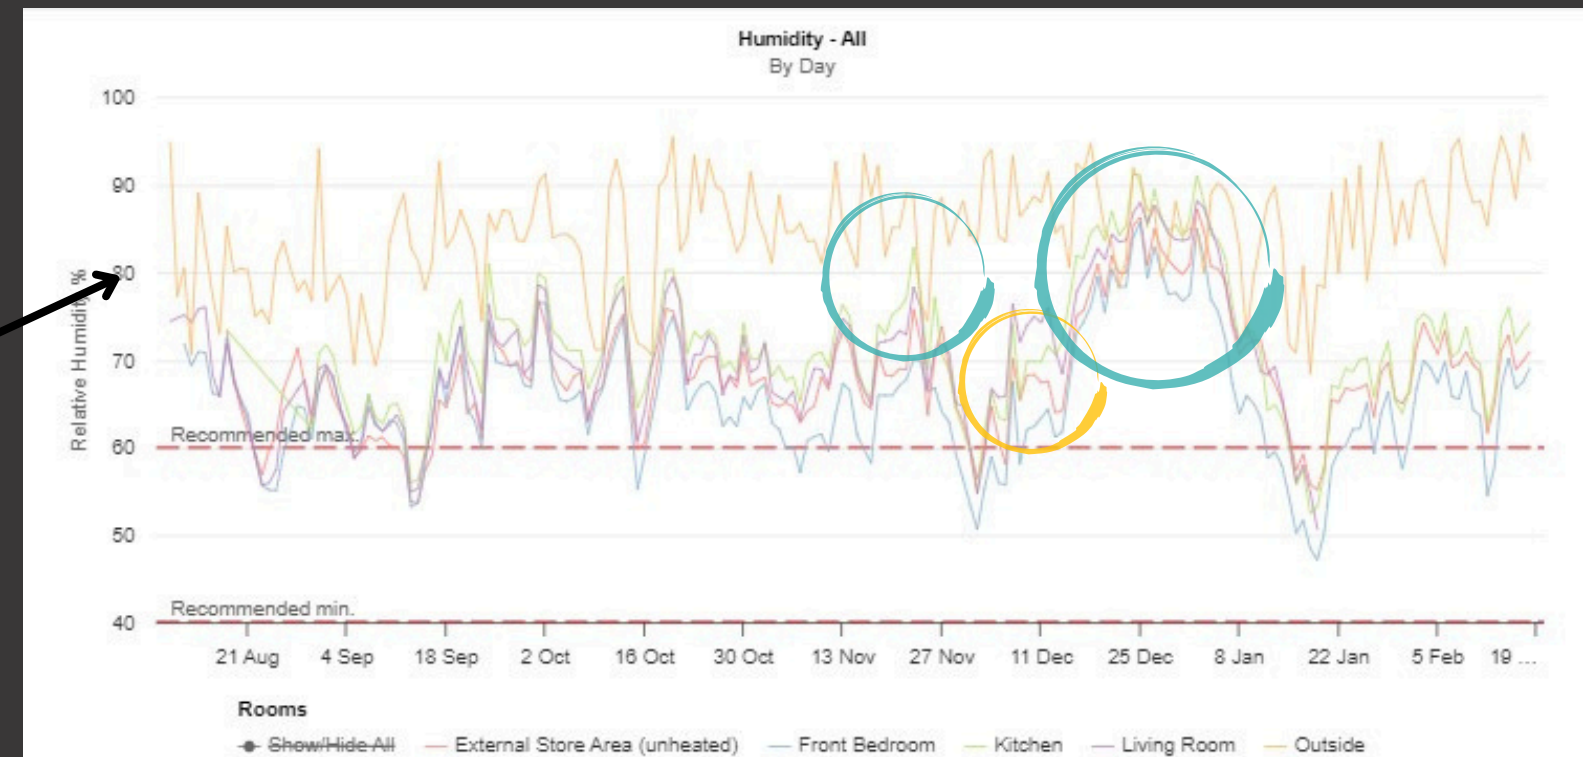
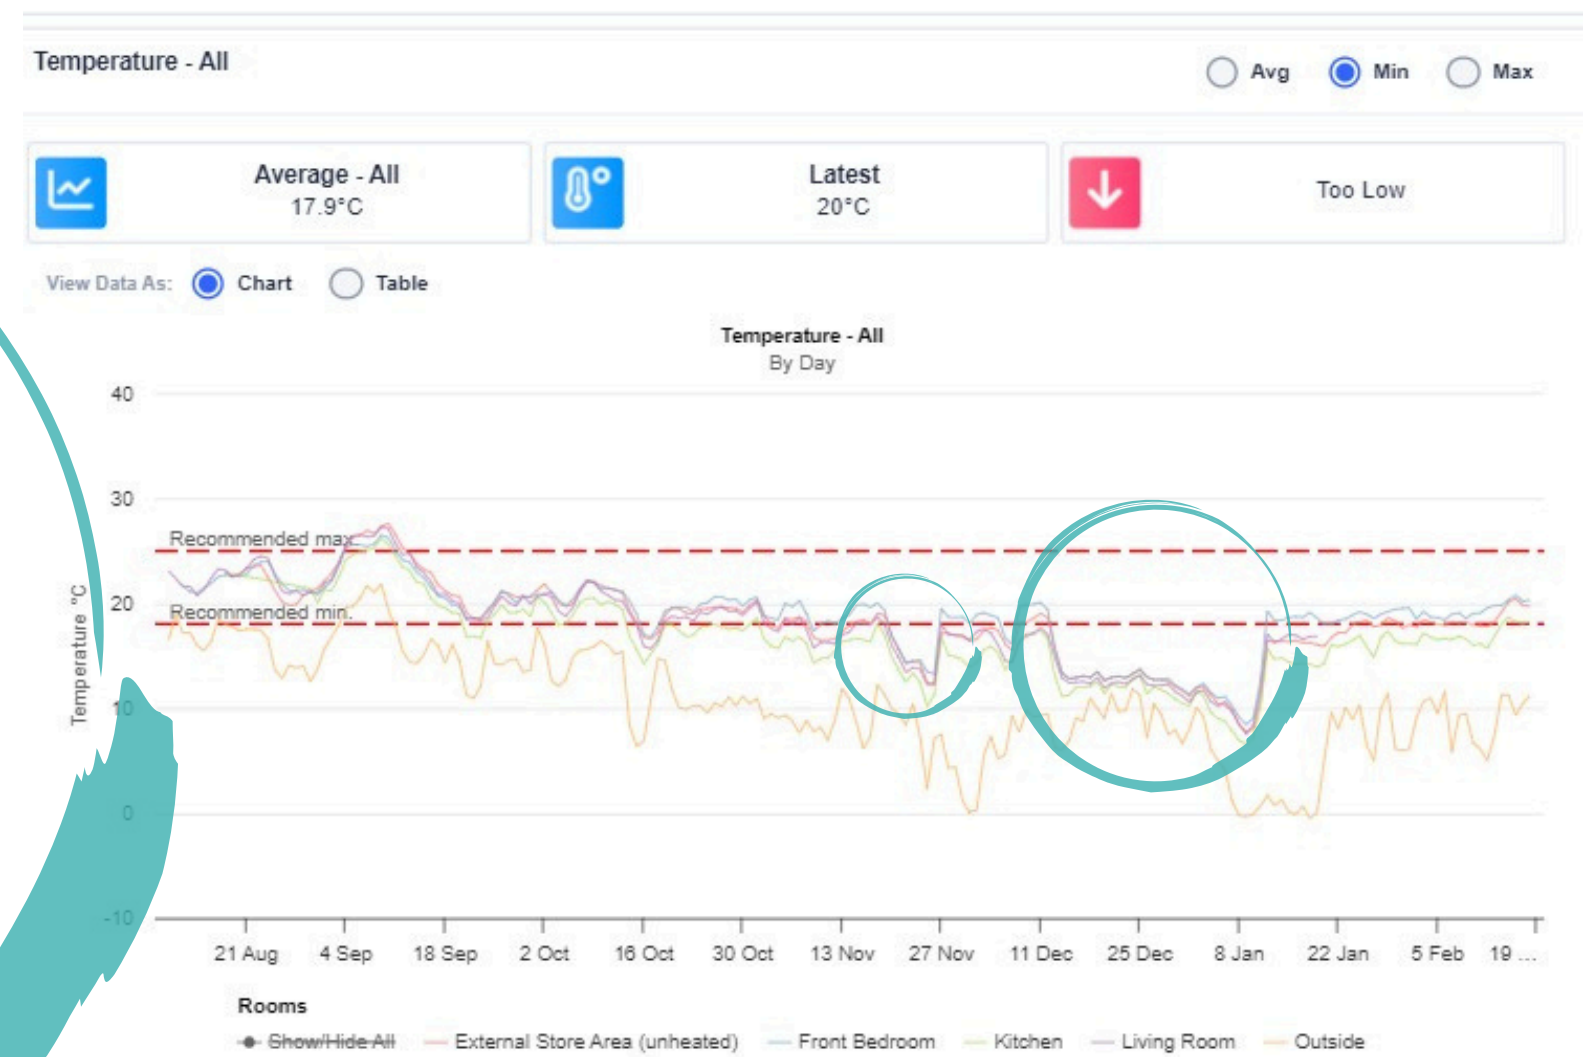
Case Study 2 Environmental Data

New roof in July 2023
resolved issue
affecting bathroom
area

Tenant advises she's not home for appointments due to being abroad - further discussions show that this is a regular event in the winter, returning to Southern Europe for periods of up to 4 weeks. Apparent that heating is turned off, rather than on a setback. Able to provide advice and continue to monitor.

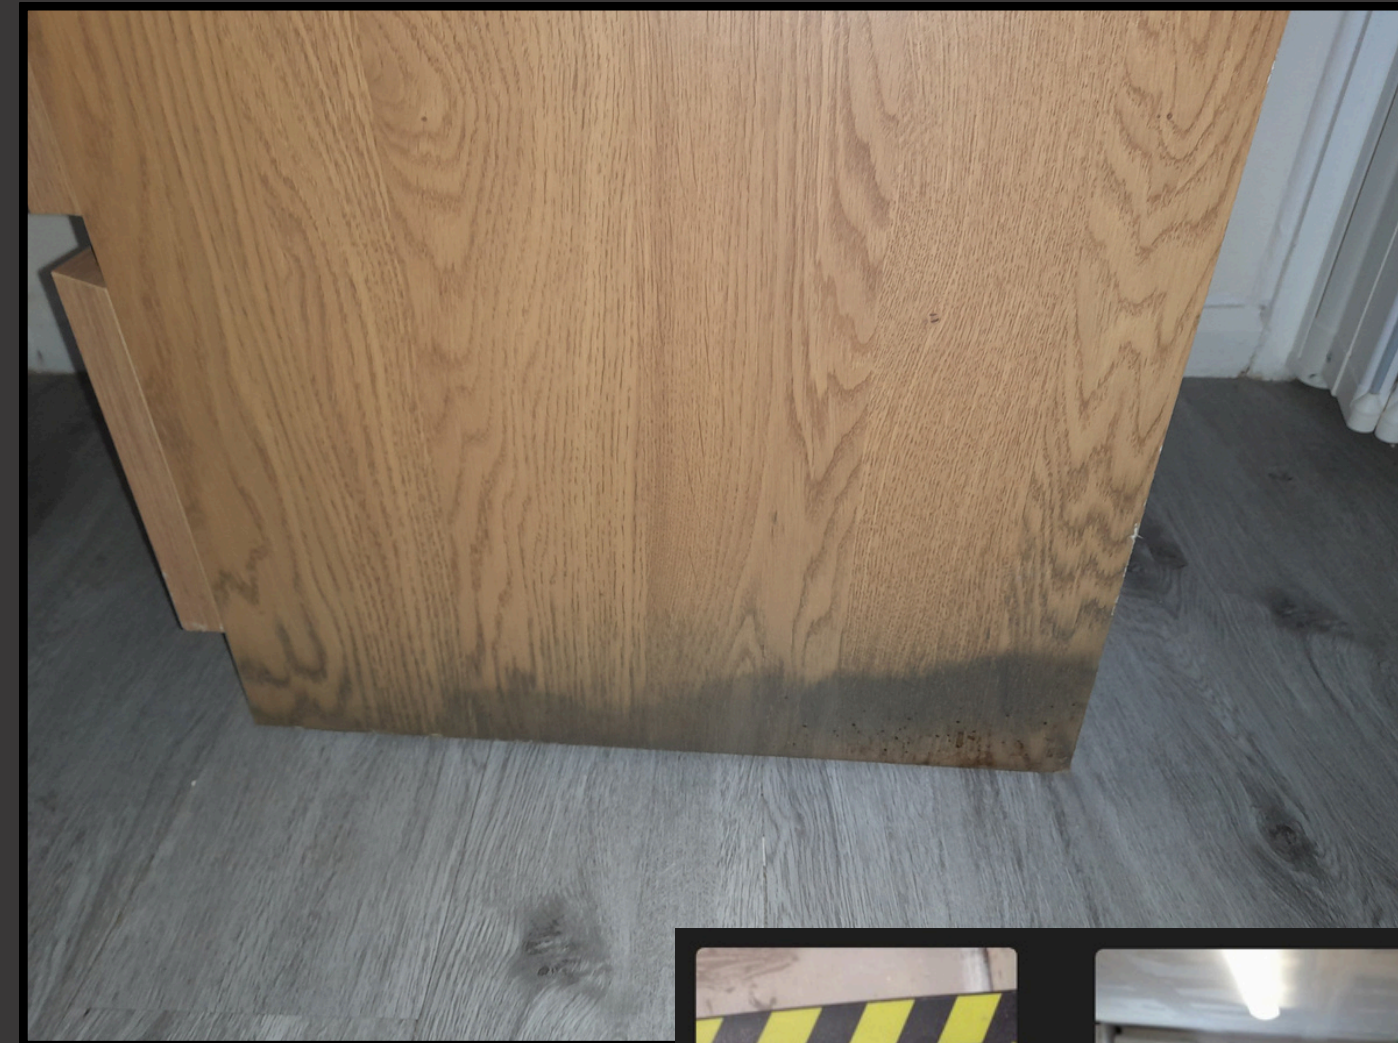
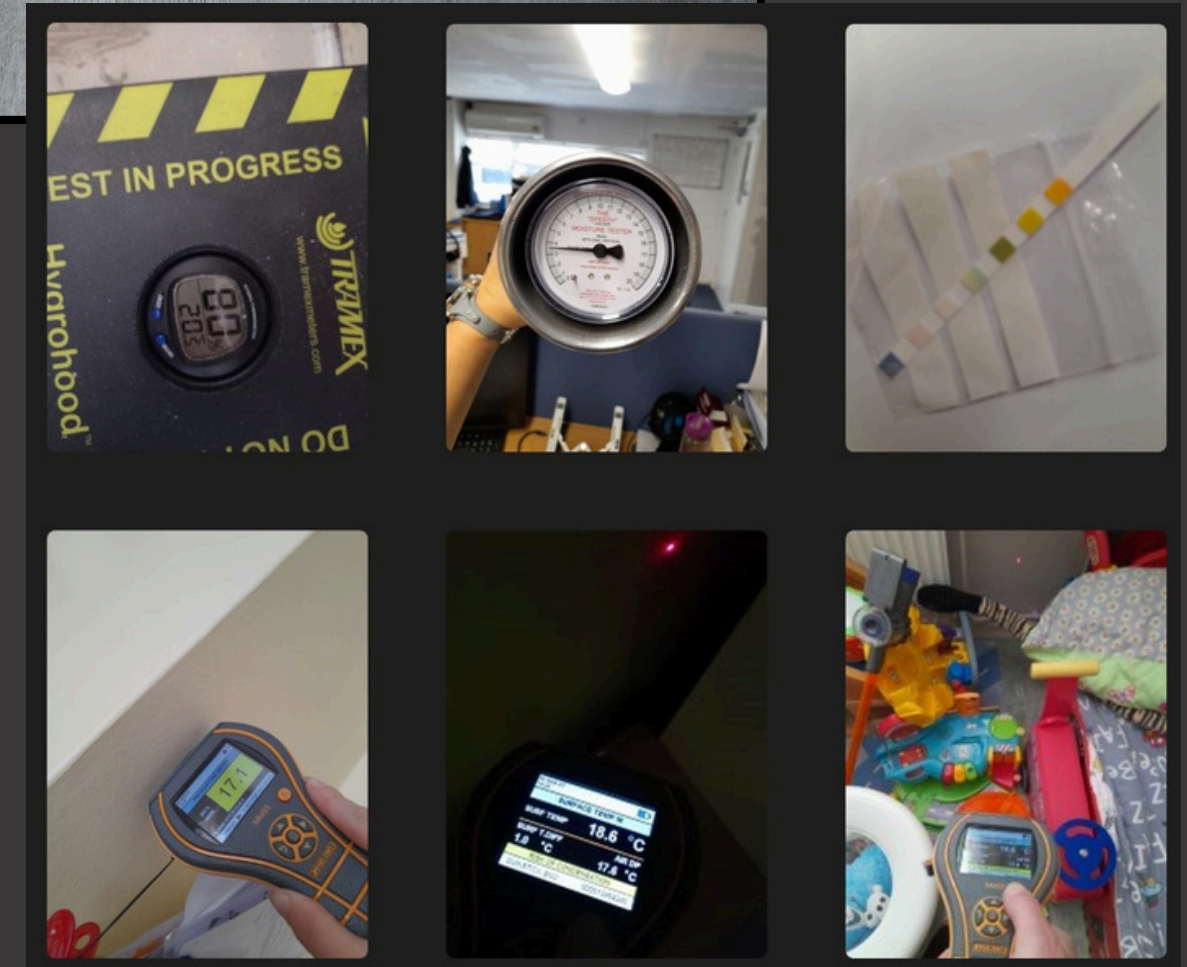
Maple Road Interventions

- More investigation than intervention
- Ventilation automated and PIV installed
- Tenants (understandably) convinced that there was moisture coming up through the floor slab. Testing showed that the more likely cause was severe condensation, but not necessarily due to a lack of ventilation
- Having monitored the properties in case studies 1 and 2 over a similar period, decided to wait for the outcome of these before rushing into 'damp proofing' works at this property

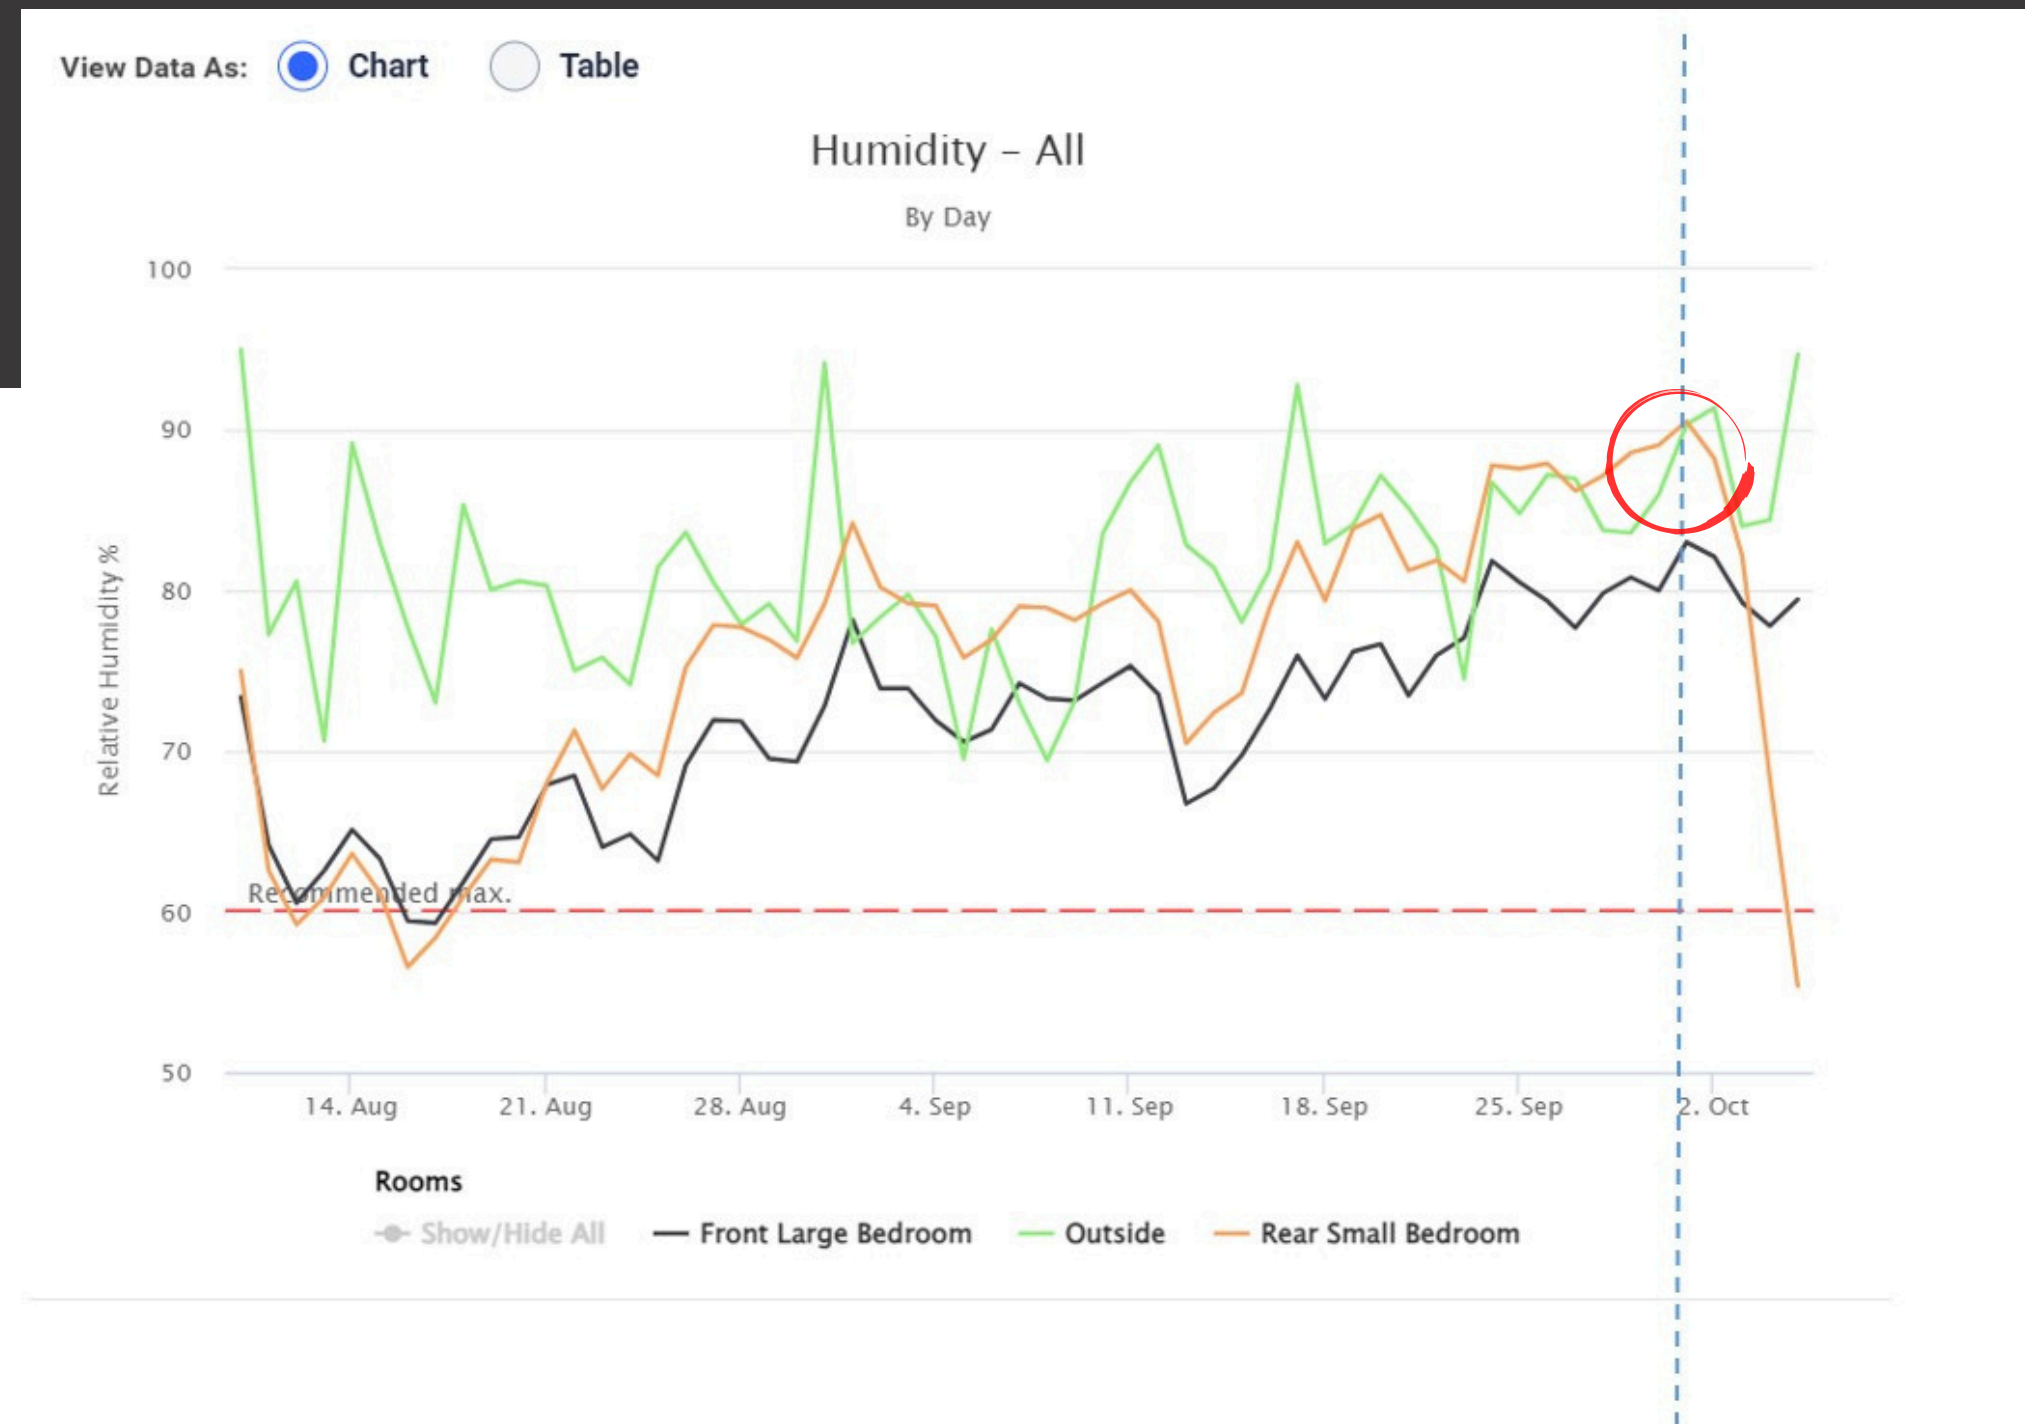
Case Study 3 Environmental Data

Key event 1

Heating in rear bedroom increased from average 18°C to around 21°C

Note - much easier to identify when monitoring daily - less noticable when viewing over a longer monitoring period

Event: Heating turned on in rear small bedroom (orange line)
