Spotlight on Damp & Mould

Mid Devon Housing's Damp, Mould & Condensation Approach

Mid Devon
Housing

Presentation date:
23 April 2024

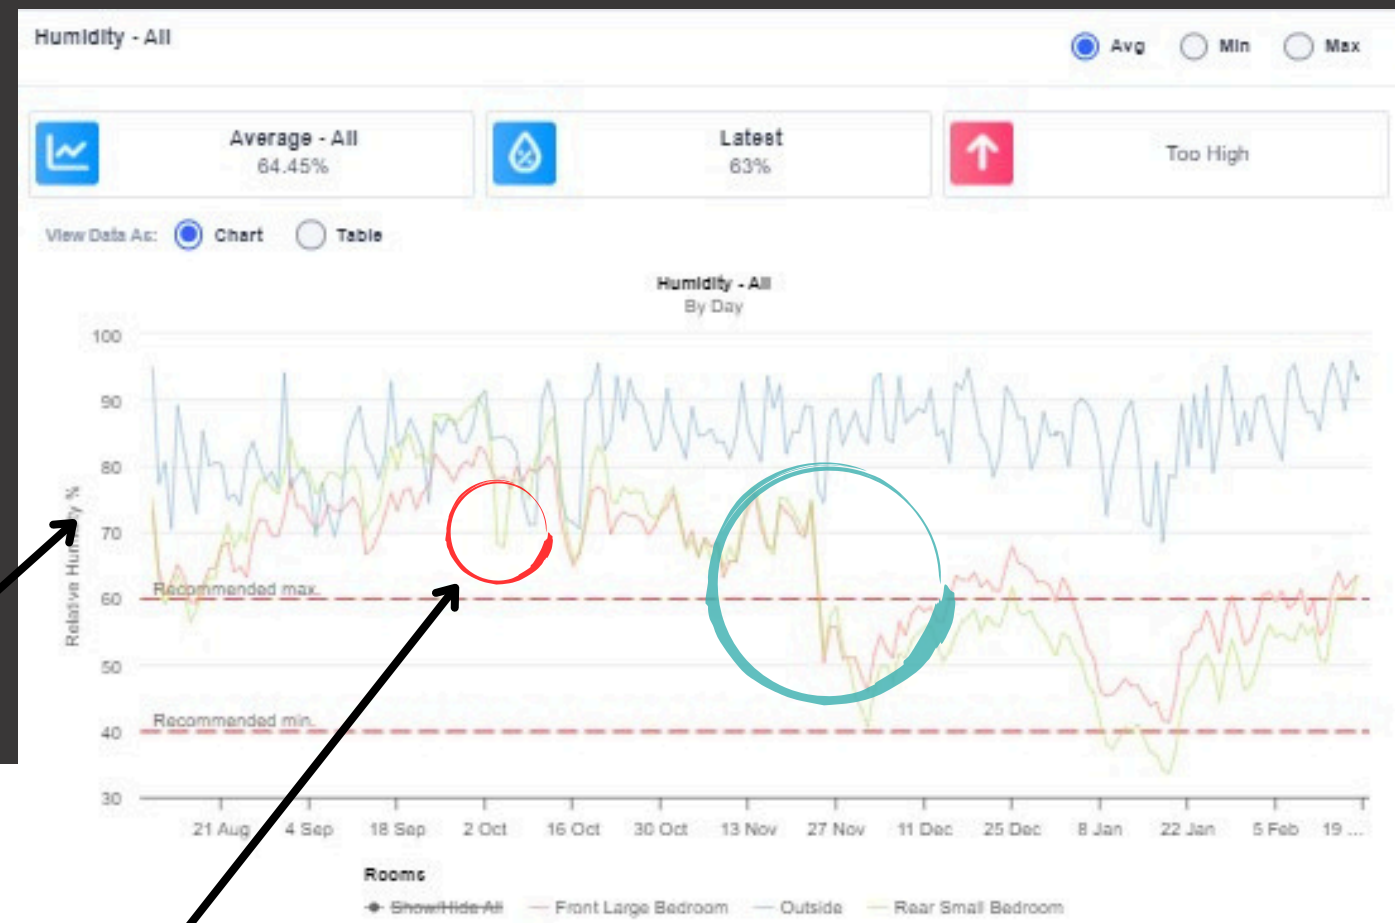
Maple Road Environmental Data

NOTE:
The first few days are often inaccurate as levels appear to build up. This data should be discounted

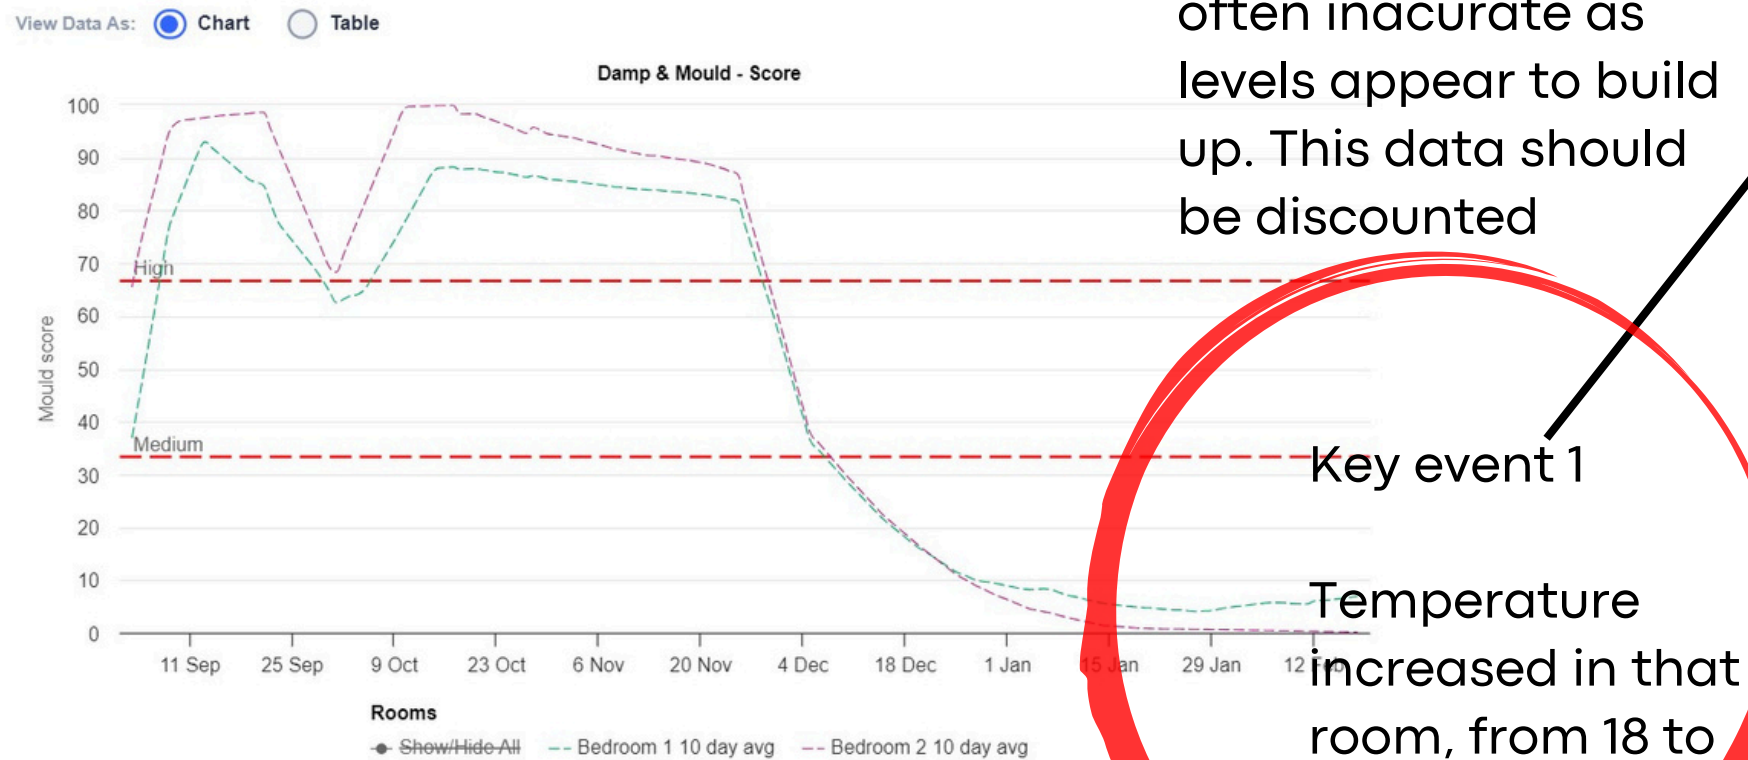
Key event 1
Temperature increased in that room, from 18 to 21°C

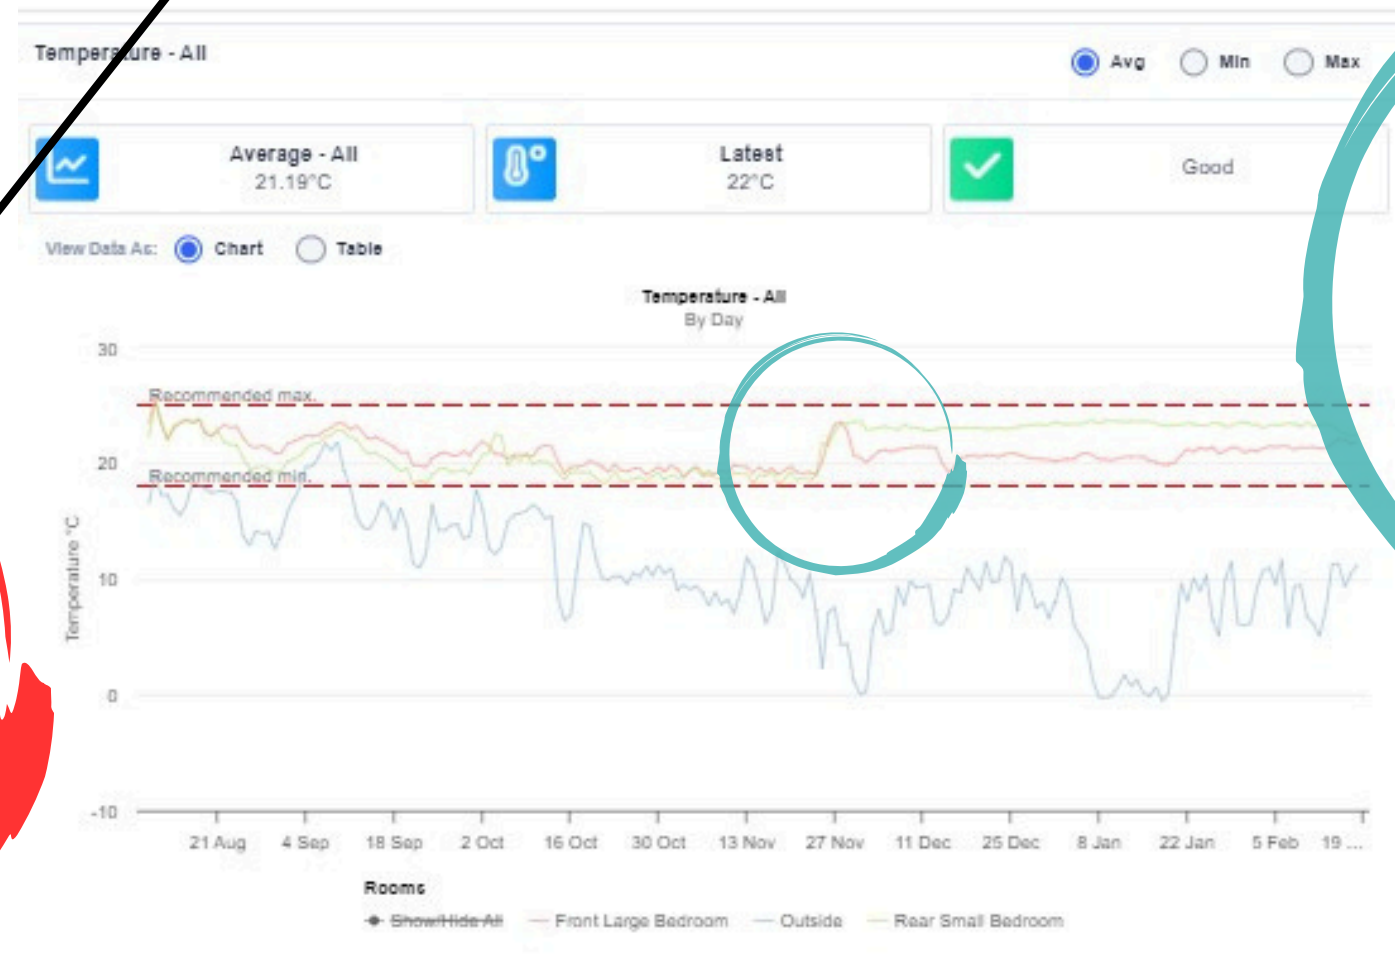
Key event 2

Mutual exchange, new tenants move in. Heating levels changed from average 18° to average 22°C

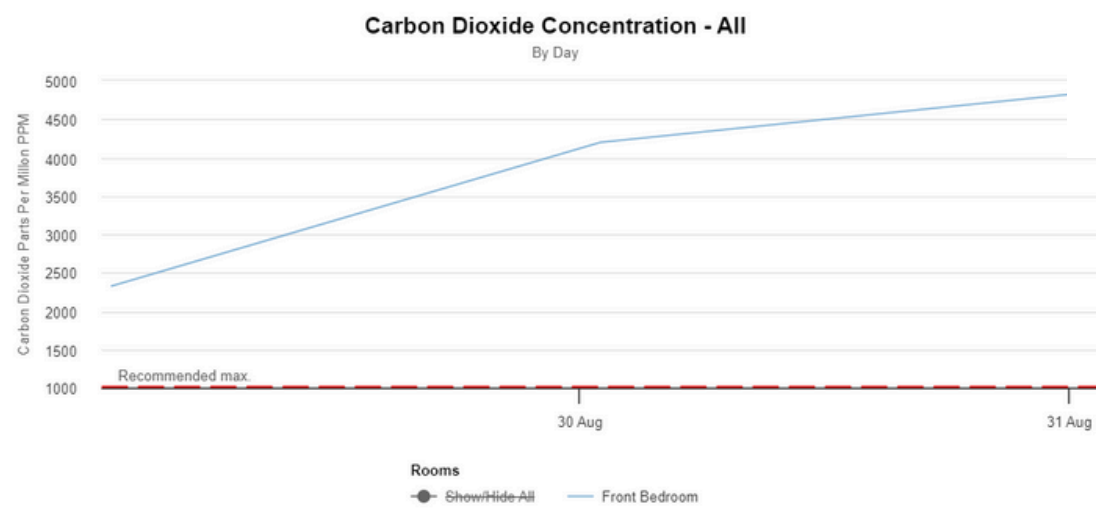
Ann and Dylan Environmental Data

Carbon Dioxide levels reached 5500ppm - well over the healthy range, and over the workplace limit.

Indication of poor ventilation and very poor air quality

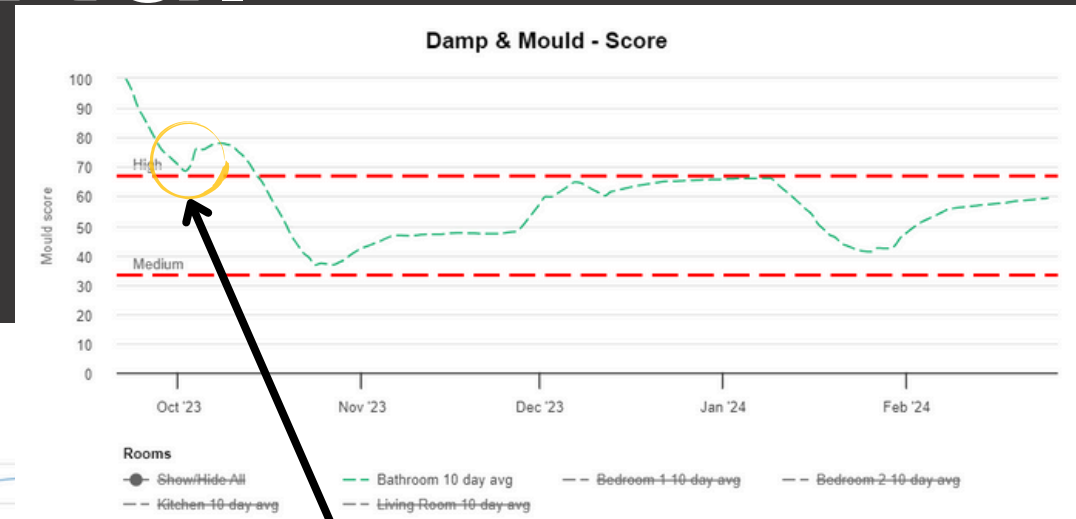
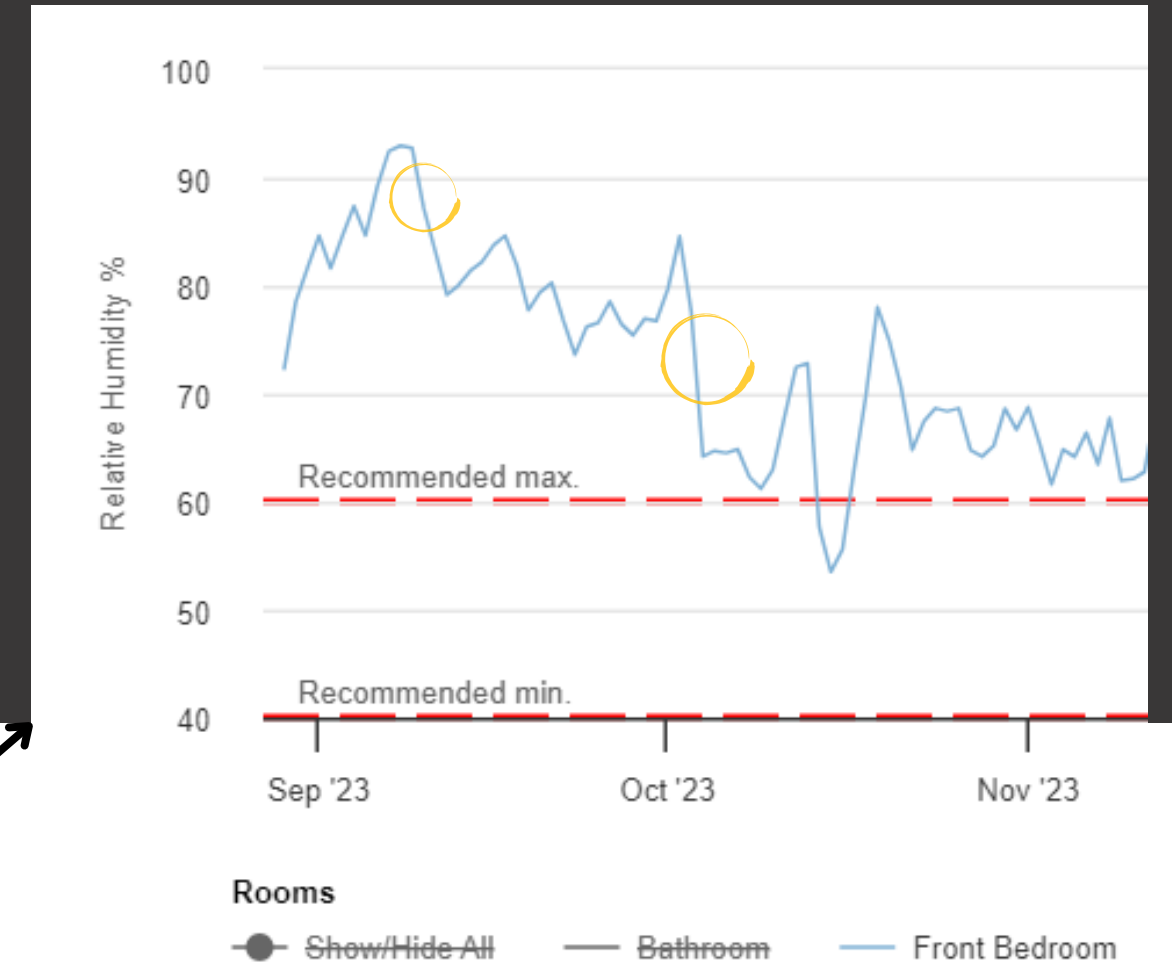
Key events

12 Sept - curtains removed, fly screen added

2 October - PIV installed in front bedroom and humidistat to bathroom fan

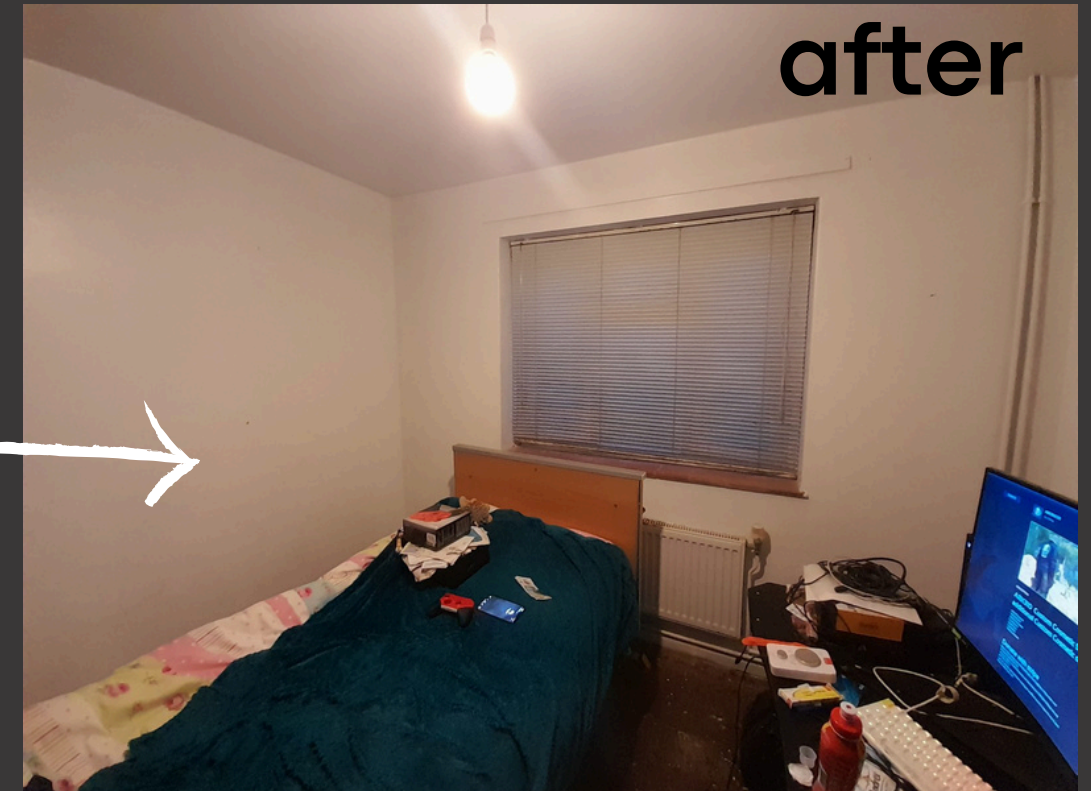
after

- Dylan's room and bathroom have reduced D&M risk since interventions
- Other rooms have increased risk of D&M and higher humidity since interventions, as we get into the winter months.
- Main corresponding change based on data available is related to low heating levels. Some of the rooms drop to average temperatures of 13°C, which is well below the level required to maintain good health and avoid mould risk. The interventions in Dylan's room and the bathroom seem to be mitigating this.
- Discussions with tenant, heating works but is manually operated. Does not want programmable - concerns about cost, complication and change.
- Further discussions about minor hoarding in other rooms - radiators and windows blocked.
